Cold Regions Research and Engineering Laboratory
Hanover, New Hampshire

Research Report 348

DETECTING STRUCTURAL HEAT LOSSES WITH MOBILE INFRARED THERMOGRAPHY

Part III-Survey of USA CRREL

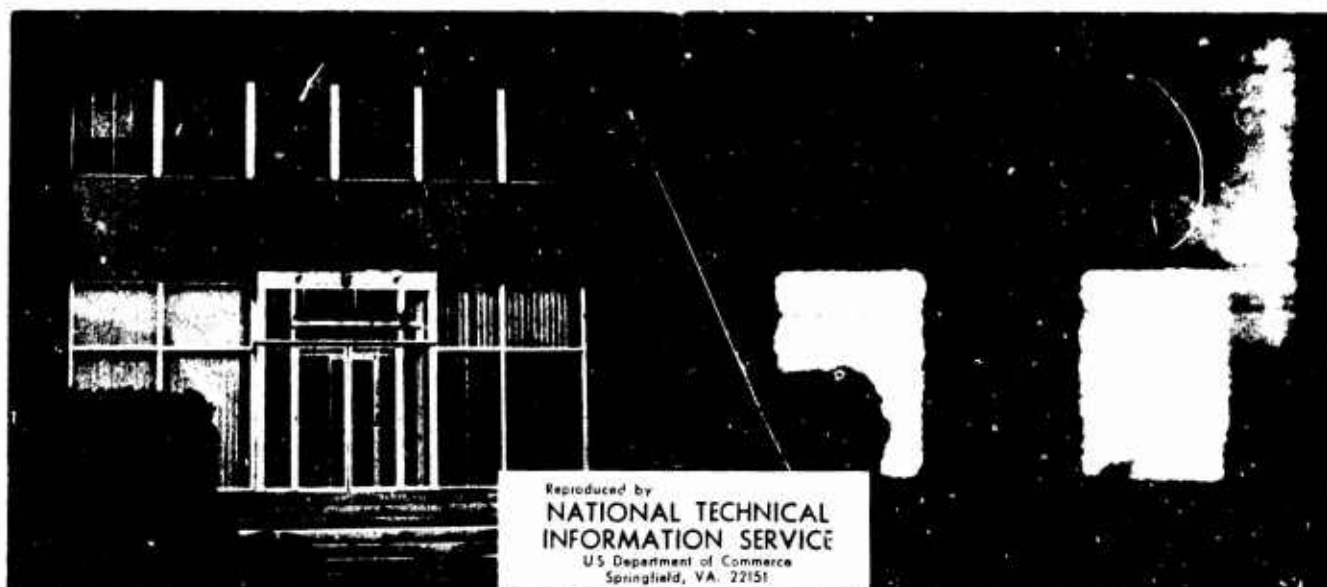
Daylight, Conventional Photograph

Nighttime, Thermogram

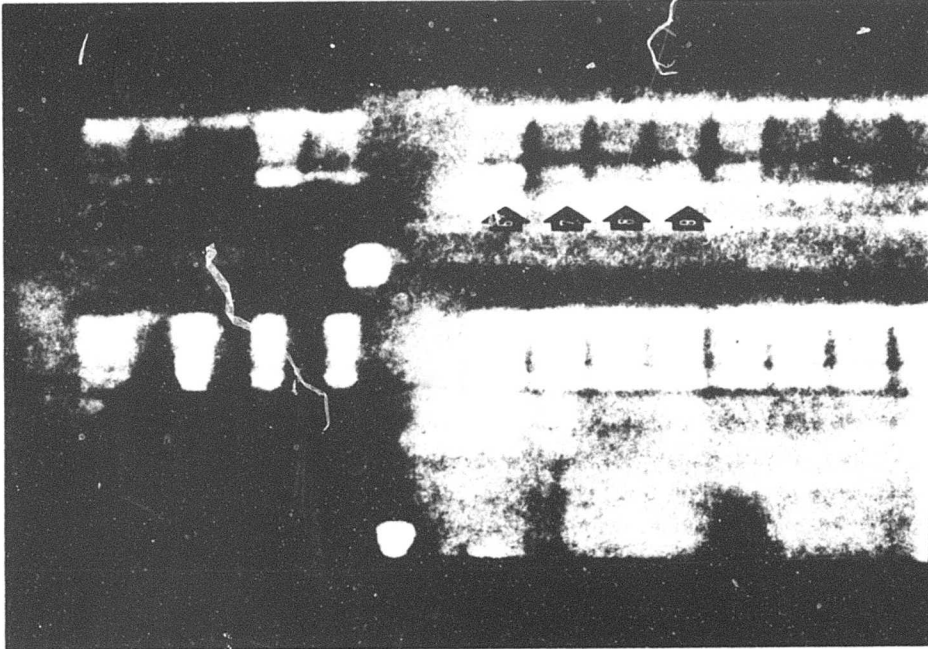
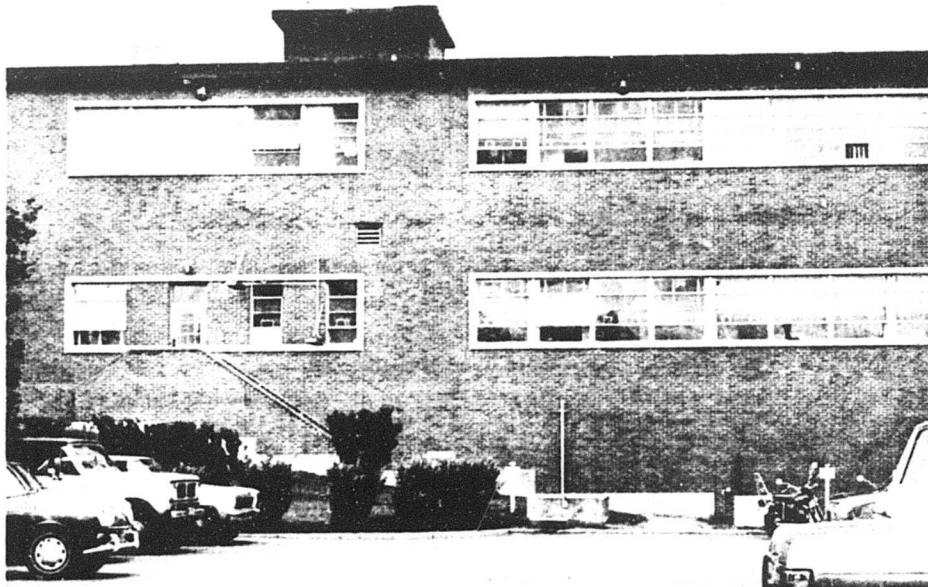
Figure 1 shows the thermogram and regular picture of the northeast side of the USACRREL building. The thermogram was taken on 13 February 1974 at approximately 2200 hours. The ambient temperature was 36°F and the wind (as measured at a station located at USACRREL) was from the south at 2 mph. The large white spot between the two rows of windows shows heat flowing out of an open vent. An interesting qualitative comparison of the relative heat flow (white to black contrast) from the five second floor windows located at the east corner of the building can be noted. Windows 1-3 are fitted with a pair of heavy drapes with a separate liner between the windows

Figure 1. Northeast side of USACRREL building. Windows are numbered to distinguish differences in heat loss. (See text.)

and the drapes, while window 6 has venetian blinds (pulled down), and windows 4 and 5 have neither blinds nor drapes. Notice that there is relatively more heat (whiter contrast) emanating from the top panes of windows 4-6 than there is from the top panes of windows 1-3. The remaining windows (all fitted with venetian blinds) on the second floor show this same pattern, indicating a rather uniform stratification of warm air near the ceiling in all the rooms in which these windows are situated. While this stratification is somewhat evident at the top panes of windows 1-3, it is obvious that the

drrape-liner combination does retard a noticeable amount of heat in comparison with the venetian blinds. However, in comparing windows 4 and 5 with those fitted with venetian blinds, it is obvious that the venetian blinds retard little if any of this layer of warm air near the ceiling from reaching the window surface.

Careful observation of window 6 shows heat escaping all along the left side of the window (top to bottom); this seems to indicate that there is a heat leak along the glass to metal casement joint or along the mortar to metal casement joint. Figure 2 shows a typical window at the USACRREL building. It is interesting to note that window 6 is the only one of the 24 windows shown in the Figure 1 thermogram that has a rather bad heat leak around the metal casement, indicating a direct flow of air from inside to outside. The top horizontal casement member on all the windows seems to be warmer than the lower casement member and the lower part of the vertical members, indicating that conductivity through these top horizontal members is being generated by the temperature gradient between this layer of warm air near the ceiling and the outside air.

The large bright area beneath window 6 is the heat from the radiator which has reached the outside surface of the building. The bright zone beneath windows 7, 8 and 9 indicates the presence of a radiator at that location. The bright spot beneath the window directly below window 6 likewise indicates the presence of a radiator. Also, the bright region below and to the left of this window indicates heat being transmitted through the wall at that location. At the edge of this bright region (arrows) is located (inside of the building) a wall separating the two rooms.

The relatively bright appearance of the lower row of windows (compared with the top row) would perhaps lead one to believe that abnormal heat leakage is occurring through these windows. However, the real reason for this high apparent heat loss is that during the survey of the USACRREL building the first floor room temperatures were consistently significantly higher than the second floor room temperatures. The Figure 1 thermogram illustrates one of several reasons that the

The heat loss survey of the USACRREL building showed a number of locations where heat was being lost that could be conserved if corrective actions were taken. Since almost all of the windows are single panes, corrective action needed to be taken to provide an additional insulating layer over the single panes. (As a result of this research it was decided that the most cost-effective approach in the interim was to put sheets of plastic over the inside window frames on the north side of the building.) The thermographic analysis also showed that in a number of places heat from the wall-mounted radiators was being lost by conduction through the masonry wall. This situation could be corrected by placing metal reflectors behind the radiators (but insulated from the wall).

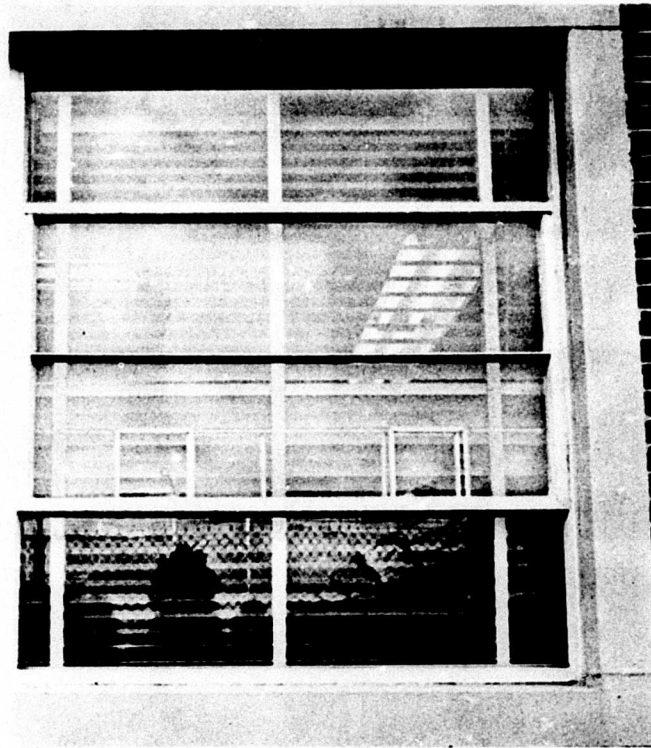
Figure 2. Typical window at USACRREL.

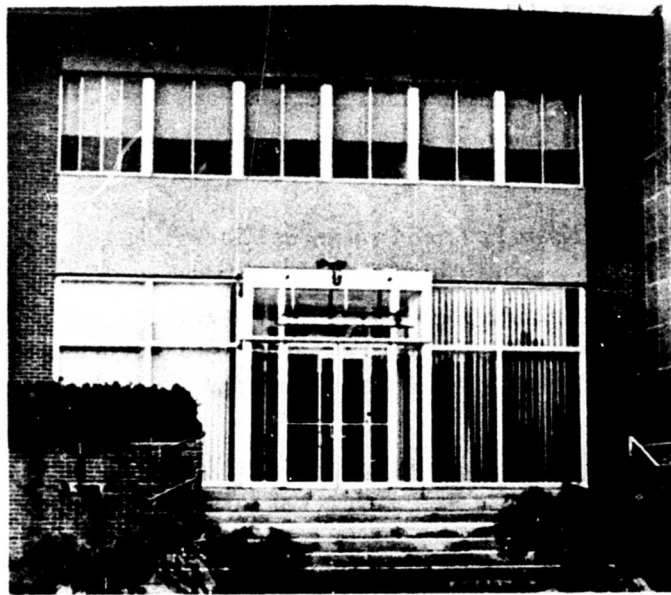
Figure 3. Main entrance of USACRREL building. Black horizontal arrows point to south-facing slate wall. White horizontal arrows point to east-facing slate wall. Each of six vertical arrows points to window with an installed storm sash.

Figure 3 shows the thermogram and regular picture of the front entrance of the USACRREL building. The most obvious heat loss (two bright rectangles) in this thermogram is through the single panes of glass in the two large windows of the lobby. Again it must be emphasized that a significant amount of this heat loss is due to the higher than normal lobby temperature which was recorded on the evening that the thermogram was taken. However, as can be seen from the dark zone between the two bright rectangles, there is a distinct advantage in having a foyer (which can act as an air lock) leading into a building. Because of the insulating value of the airspace in the foyer, the heat flow at this location is approximately only one-fourth of that occurring through each large window.

In the same manner, the added value of storm windows is illustrated in Figure 3 (six vertical arrows). Each arrow points approximately to the bottom of a window which has a storm sash installed. Comparison of the white-black contrast at this location with that observed at the foyer indicates that the insulation effectiveness of a storm window is comparable to that of the foyer.

The large bright area (horizontal black arrows) to the right and above the lobby windows illustrates another important point regarding thermographic analysis. The black arrows point to the relatively warm south-facing slate wall of the auditorium-library extension, while the vertical white arrows

point to the cool east-facing slate wall. One might immediately conclude that all of this heat is escaping through the wall from the inside. However, several factors must be taken into consideration before a final conclusion can be reached. When this thermogram was taken (2100 hours), the air temperature was 36°F. Although the sky had been overcast part of the day, there had been a few hours of sunshine during both morning and afternoon. The combination of solar heating of the slate, an abnormally warm air temperature, the protected exposure of the south-facing wall, and a low wind velocity (southerly at 2 mph) serves to explain why the south-facing wall of this extension is warmer than the east-facing wall.

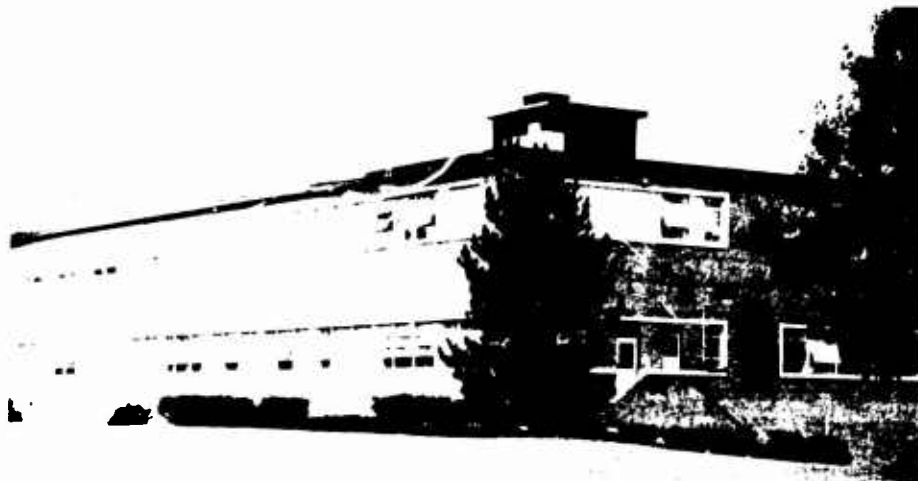
Figure 6. Northeast corner of USACRREL building. Arrows point to wall surface heated by radiators.

Figure 6 shows the thermogram and regular picture of the northeast corner of the building. Arrows point to locations of outside wall surface heated by radiators mounted on the wall directly behind these heated areas.

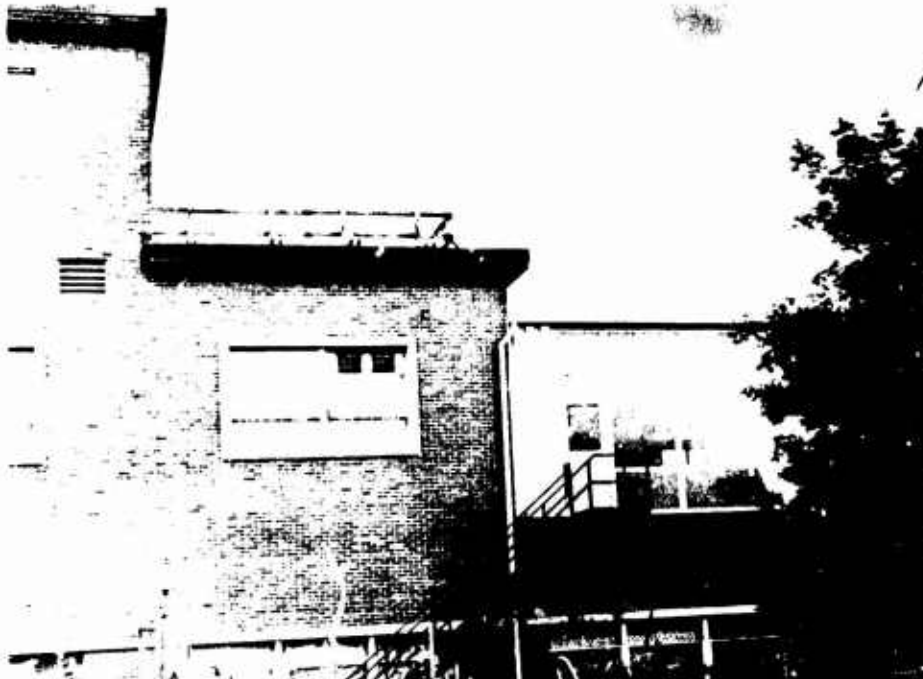
Figure 8 shows the thermogram and regular picture of the west side of the north-facing wall. The white zone (lower arrows) underneath two of the cafeteria kitchen windows indicates an excessive loss of heat at that location, attributed to a tank of hot water kept at 200°F and a section of the

Figure 8. West side of north-facing wall. Lower arrows point to heat escaping by conduction through wall of the cafeteria kitchen. Upper arrows point to heat escaping by conduction through wall of second floor office. White arrows point to location of heat leak (see Fig. 7).

room heating unit. The white zone to the upper left (upper arrows) indicates that this radiator is on and that a significant amount of the radiated heat is being conducted directly through the wall. The faint white line (white arrows) between the two large north dining area windows indicates a possible heat leak at the roof-wall joint of this metal building. Another view of this location can be seen in Figure 7 (arrow at extreme left side of thermogram).
